# The Uniform Building Inspection Report™

**Condominium:**  
1926 Huxley Ct., San Jose, CA

**Inspection Date:**  
9/15/2009, 11:00:00 AM

**Report Number:**  
20090915

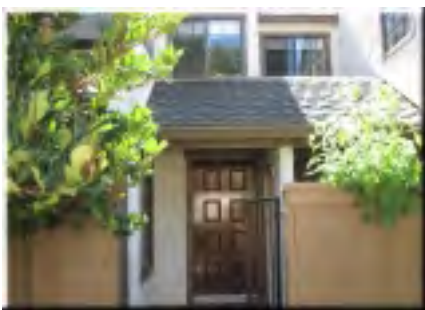
Photo: 0847.05 (1)

[R] 0847.05: HOA NOTE: The inspector was informed by the client or agent that the residential dwelling unit is part of a complex that is managed and maintained by a "Home Owners Association" (HOA) that inspects and maintains the "common areas" (all but within the dwelling units). This inspection will be limited to systems and components that are located within the individual dwelling unit inspected and does not include the "common areas." Recommend buyers review the HOA's Proforma Operating Budget, including the Reserve Study, which is required to provide the current condition and anticipated remaining life expectancies of the major systems & components maintained by the HOA. The Reserve Study should be reviewed for disclosure of pertinent facts that could affect the current condition or market value of the individual dwelling unit or the complex's common areas/elements. The budget should include a statement of present funds and funding strategy to cover future major repairs/replacements. Recommend reviewing the Covenants, Conditions & Restrictions ("C.C. & R's") to determine whether any of the common areas/elements are the responsibility of the home owner to maintain. It is also recommended that the buyer consult with the current seller (property owner) and the HOA regarding known past and present defects and all corrective work performed to help ensure relevant disclosure of conditions that may

not be discovered during this home inspection within the dwelling unit. Any comment in this home inspection report regarding a condition in a common area" has been included solely as a courtesy and should be brought to the attention of the HOA or their representatives. See Photo(s) 0847.05.

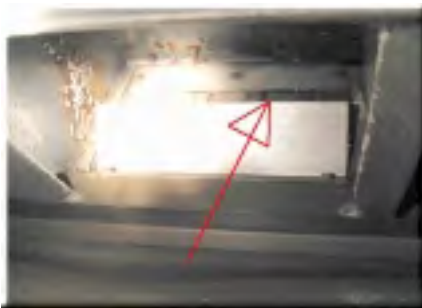
Photo: 2005.08 (1)

[R] 2005.08: Furnace interior near/in heat exchanger and other areas showing signs of corrosion. Corrosion may be on surface only, but if heat exchanger corrosion extent is sufficient to cause holes or cracks, carbon monoxide could combine with the circulation air for rooms. Carbon monoxide is odorless, colorless, and can be fatal in sufficient amounts. Corrosion extent needs further evaluation that requires disassembly, which is beyond the scope of a Home Inspection. Furnace is also aged and may be at, or near, the end of its useful life. Recommend the heat exchanger and remaining furnace be reviewed, serviced, and corrected as needed, by a qualified licensed HVAC contractor. See Photo(s) 2005.08.

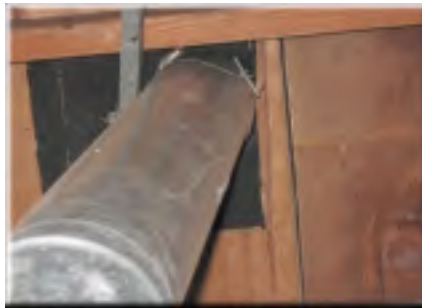
Photo: 2013.05 (1)

risk of fire. Vent heats up from furnace burner exhaust. Continual heat exposure to certain combustibles can lower the ignition temperature of the combustible material over time, possibly causing these combustibles to eventually ignite when exposed to the same temperature it has been exposed to over time. Also, furnace servicing may not have been performed routinely. Recommend that this finding and all associated components be reviewed, and corrected as needed, and furnace servicing be performed by a qualified licensed HVAC contractor. See Photo(s) 2013.05.

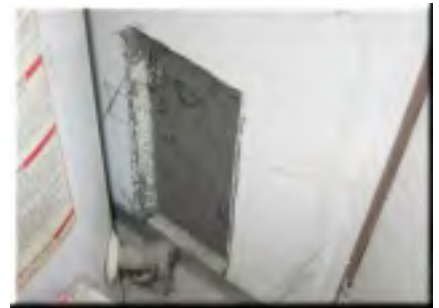
Photo: 2024.10 (1)

[R] 2024.10: Ventilation screen at bottom of furnace closet is partially clogged with debris, possibly preventing sufficient air from being available for furnace burner or preventing sufficient ventilation of carbon monoxide, which may emanate from water heater under certain circumstances. Carbon monoxide is odorless, colorless, and can be fatal in sufficient amounts. Cleaning of vent recommended. See Photo(s) 2024.10.

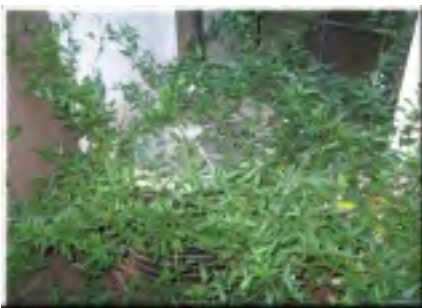
Photo: 2036.10 (1)

[R] 2036.10: Air conditioner's exterior condenser unit on front patio has vegetation too close to fins/fan, possibly restricting designed air flow and affecting

operation, cooling efficiency, and energy costs. Many unit manufacturers require sufficient clearance because large fan on top of unit needs to circulate a large volume of air at a fast rate. Recommend the vegetation be pruned at least 12 inches away from condenser by a qualified person. See Photo(s) 2036.10.

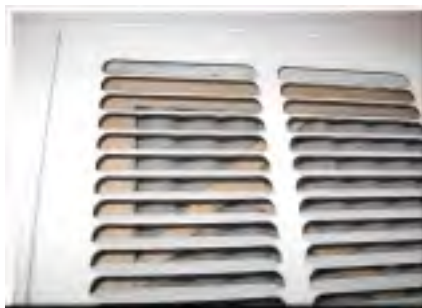
Photo: 2205.05 (1)

[R] 2205.05: Furnace filter in wall adjacent to stairs appears dirty. Replacement can be expected to help maintain air quality, proper/safe operation, and heating/cooling efficiency. Recommend filter replacement by a qualified person. See Photo(s) 2205.05.

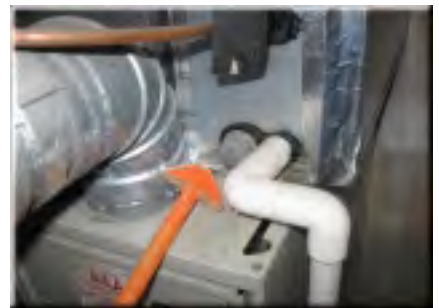
Photo: 2304.05 (1)

[R] 2304.05: Secondary condensate drain pipe not installed on interior air conditioner evaporator unit in attic. Secondary pipe allows drainage when primary pipe is clogged and helps prevent water damage to wood ceiling and building materials below. Recommended installation of a secondary condensate pipe by a qualified, licensed HVAC contractor. See Photo(s) 2304.05.

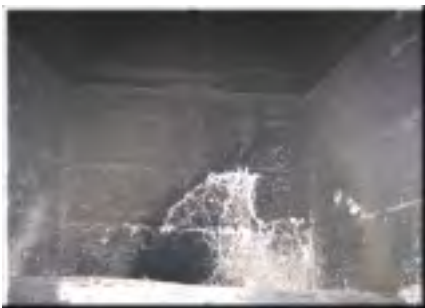
Photo: 2667.23 (1)

[R] 2667.23: Fireplace/chimney interior has soot. May be sufficient to need cleaning. Soot may hide

material defects or increase the risk of a chimney fire. Further review by a chimney specialist would be required to determine whether cleaning is necessary. Also, fireplaces/chimneys can have defects that may not become apparent during the limited scope of a home inspection, such as proper installation, assessing structural integrity, and fire/smoke barrier integrity. Fireplace/chimney defects can possibly cause property damage, injury, or fire. Recommend that the fireplace and chimney be reviewed, and proper installation according to the manufacturer's installation instructions be confirmed, by a qualified, licensed chimney specialist. See Photo(s) 2667.23.

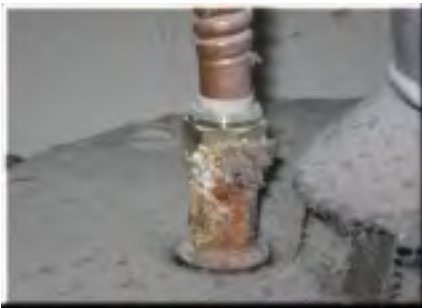
Photo: 4022.25 (1)

[R] 4022.25: Pipes / fittings atop water heater have corrosion. Could cause rusty water, reduced water supply flow, or leak. May indicate corrosion of interior water heater components. Water heater is also aged and may be at, or near, the end of its useful life. Recommend that this finding and the remaining water heater be reviewed, and corrected as needed, by a qualified licensed plumbing contractor. See Photo(s) 4022.25.

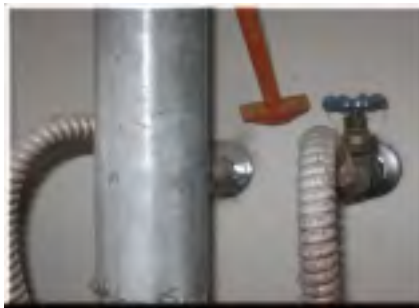
Photo: 4022.30 (1)

[R] 4022.30: Water pipes on top of water heater are not electrically "bonded" (wire connected to both water pipes). Water supply pipes are sometimes used to carry electrical current to ground or may be energized for some reason. Bonded water heaters have a wire installed between the water pipes to provide a path for any stray electrical current to flow from one pipe to the other instead of through a person who is touching the pipe carrying current. Although bonding may not have been required at the time of construction, safety upgrade is advised. Recommend that this finding and all associated components be reviewed, and corrected as needed,

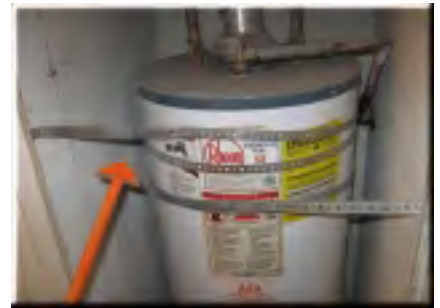
Photo: 4025.05 (1)

[R] 4025.05: Water heater has seismic restraint straps & fasteners that are insufficient. An earthquake can move an insufficiently secured water heater and cause a gas leak that can be ignited by the burner and cause a fire or explosion. Recommend that this finding and remaining water heater be reviewed and corrected as needed by a qualified licensed plumbing contractor. See Photo(s) 4025.05.

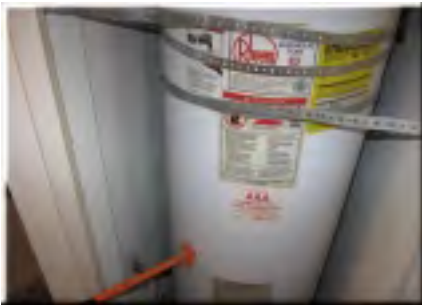
Photo: 4025.35 (1)

[R] 4025.35: Water heater in upper level water heater closet does not have a seismic restraint strap installed on lower third of water heater, where required to accompany an upper strap. An Earthquake can move an insufficiently secured water heater and cause a gas leak that can be ignited by the burner and cause a fire or explosion. Recommend that this finding and remaining water heater be reviewed and corrected as needed by a qualified licensed plumbing contractor. See Photo(s) 4025.35.

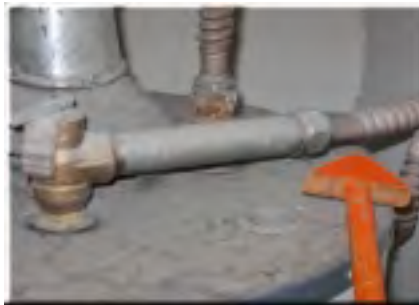
Photo: 4033.05 (1)

[R] 4033.05: Pipe for temperature/pressure relief valve on water heater has a smaller diameter than the diameter of the valve, which may restrict flow through

pipe. This pipe discharges very hot water at when water temperature or pressure is too high in order to prevent water heater explosion. Entire pipe should the same diameter as the valve to avoid trapping water or damaging valve. It is recommended that this finding and the remaining water heater be reviewed, and corrected as needed, by a qualified licensed plumbing contractor. See Photo(s) 4033.05.

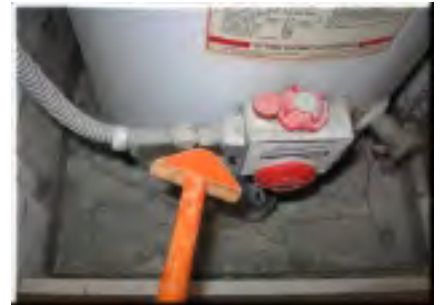
Photo: 4035.35 (1)

[R] 4035.35: Sediment trap for gas pipe to water heater has not been installed, possibly allowing sediment in gas to affect burner operation or cause the gas valve to remain open, which can possibly cause a fire or explosion. Most water heater manufacturers require sediment traps, and lack of a sediment trap may void the water heater warranty. Recommend that a sediment trap be installed by a qualified licensed plumbing contractor. See Photo(s) 4035.35.

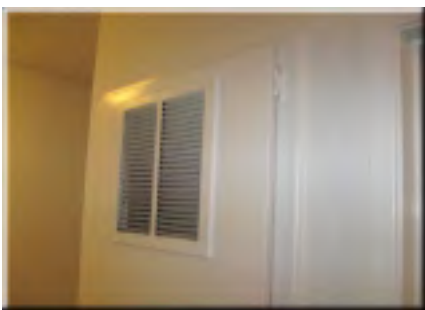
Photo: 4051.27 (1)

[R] 4051.27: Door to water heater closet is a vented door. Gas appliances under certain circumstances can emit carbon monoxide, which is odorless, colorless, and can be fatal in sufficient amounts. Water heater already has upper and lower vents in that closet that allow air communication solely with the exterior air. Door could be replaced with non-vented door. Recommend that this finding and all

associated components be reviewed, and corrected as needed, by a qualified licensed plumbing contractor. Recommend installing carbon monoxide alarms near the closet and in bedrooms, and wherever recommended by the alarm manufacturer. See Photo(s) 4051.27.

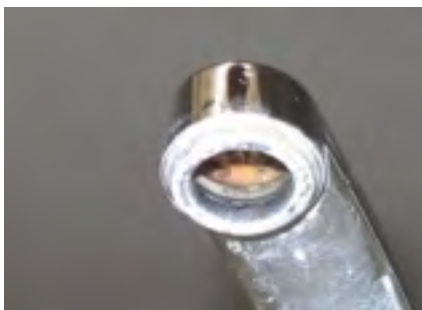
Photo: 4510.80 (1)

[R] 4510.80: Aerator for kitchen sink spout is missing, causing excessive, and unfiltered, water flow. Recommend that this finding and all associated components be reviewed, and corrected as needed, by a qualified, licensed plumbing contractor or other qualified person. See Photo(s) 4510.80.

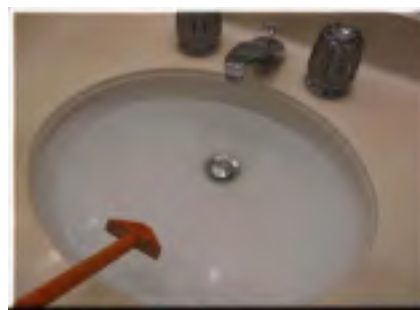
Photo: 4602.45 (1)

[R] 4602.45: Sink in lower level bathroom drains slowly. Apparent drain restriction. Recommended that this finding and all associated components be reviewed, and corrected as needed, by a qualified, state licensed plumbing contractor. See Photo(s) 4602.45.

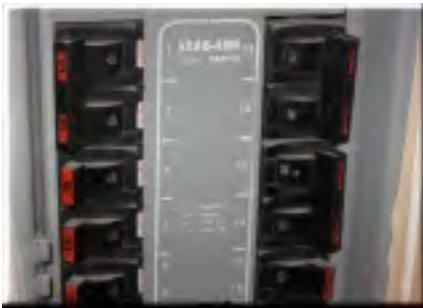
Photo: 5105.15 (1)

[R] 5105.15: Electrical sub-panel in front of lower level bathroom is a Federal Pacific "Stab-Lok" brand, which has an increased risk of causing electrical fire, shock, or electrocution. Breakers may not trip off during over-current condition, causing circuit overheating and fire. Breakers in the off position may not disconnect current to wires, causing a shock/electrocution hazard. These panels can have additional problems. Recommend that this finding, and any other panels, be reviewed, and corrected as needed, by a qualified licensed electrical contractor familiar with these FPE panel issues. Information is available at [www.inspect-ny.com/fpe/fpepanel.htm](http://www.inspect-ny.com/fpe/fpepanel.htm). See Photo(s) 5105.15.

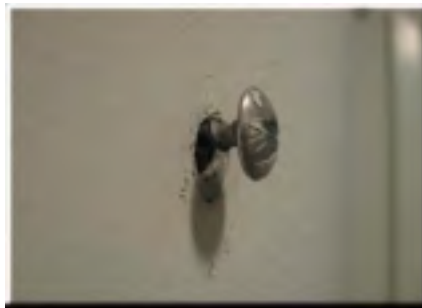
Photo: 5125.05 (1)

[R] 5125.05: Screw to secure upper right corner of sub-panel will not tighten completely using a standard screw driver. Recommend that this finding and all associated components be reviewed, and corrected as needed, by a qualified, licensed electrical contractor. See Photo(s) 5125.05.

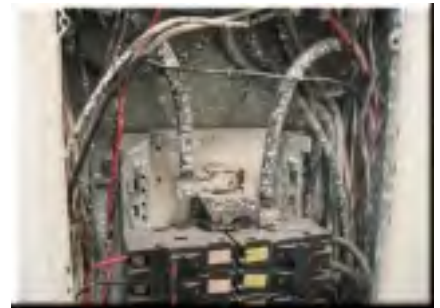
Photo: 5165.05 (1)

level bathroom has paint/texture or other wall covering spray apparent on sub-panel interior wiring and other components, possibly causing poor electrical connections or degradation of insulation materials, which may affect user safety, such as increase risk of fire. Extent in this panel may, or may not, be significant. Recommend that this finding, and remaining panel, be reviewed, and corrected if needed, by a qualified licensed electrical contractor. See Photo(s) 5165.05.

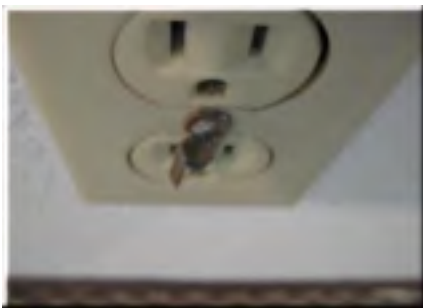
Photo: 5610 (1)

[R] 5610: Receptacle adjacent to cabinets near front door has 2-hole adapter grounding spade protruding from screw, increasing risk of injury. Recommend removal. See Photo(s) 5610.

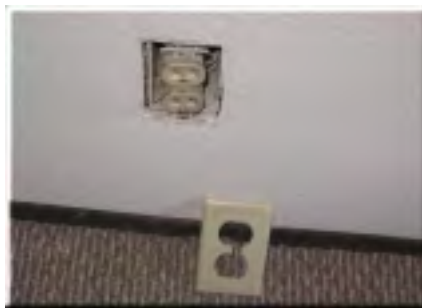
Photo: 5640 (1)

[R] 5640: Face plate for electrical receptacle in right bedroom on left wall is damaged and separated, exposing current-carrying components, which creates a risk of shock/electrocution. Replacement of face plate by a qualified person advised. See Photo(s) 5640.

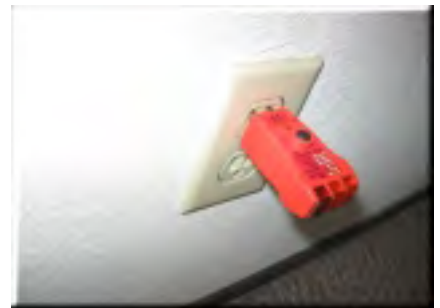
Photo: 5650.20 (1)

[R] 5650.20: Upper receptacle outlet on right wall in right bedroom does not have electrical current. Recommend that this finding and all associated components be reviewed, and corrected as needed, by a qualified, state licensed electrical contractor.

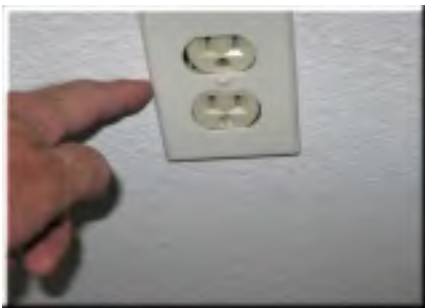
Photo: 5660.20 (1)

[R] 5660.20: Receptacle on living room left wall and receptacle on right bedroom left wall are loose. May cause wire damage or compromise connections, increasing risk of overheating, arcing, or fire. Other receptacles not tested during representative sampling may also be loose. Recommend that this finding, all associated components, and remaining receptacles be reviewed, and corrected as needed, by a qualified licensed electrical contractor. See Photo(s) 5660.20.

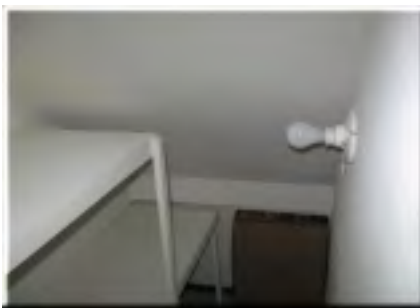
Photo: 5680.01 (1)

[R] 5680.01: Light fixture in lower level storage closet has an exposed bulb near shelving, creating a burn or broken glass injury hazard, either from bulb contacting arms or hands reaching for items on adjacent shelf or from carried item contacting bulb and breaking it. A number of these situations occur due to this condition each year. Caution is advised. Although this installation may have been common at the time of construction, recommend upgrading by replacing fixture with fixture that has a globe to cover bulb to reduce these risks. See Photo(s) 5680.01.

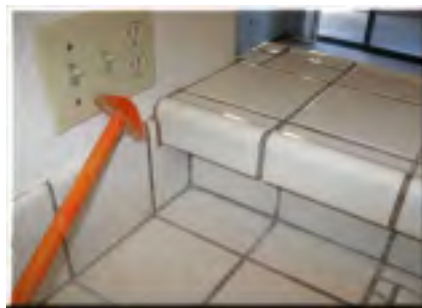
Photo: 5760 (1)

[R] 5760: Electrical receptacles in kitchen are not the type with GFCI shock protection. GFCI receptacles have a button that pops out and shuts off electricity at the receptacle before shock/electrocution

from an appliance ground fault, which would be more severe if the person was in contact with water/liquid. Although GFCI receptacles may not have been required at this location at the time of construction, recommend upgrading by having GFCI receptacle(s) installed by a qualified licensed electrical contractor to reduce the risk of ground fault shock/electrocution and meet current conventional construction safety practices. Ideally, GFCI receptacles should be installed in bathrooms, kitchen, laundry area, garage, exterior, and any area near water. See Photo(s) 5760.

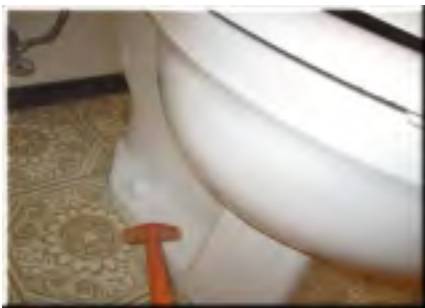
Photo: 6200.01 (1)

[R] 6200.01: Toilet bowl in upper level bathroom is not adequately secured to floor. Can compromise drain seal and cause damage to flooring and sub-floor. Recommend that this finding and all associated components, including seal integrity and sub-floor condition under toilet, be reviewed and corrected as needed by a qualified licensed plumbing contractor. See Photo(s) 6200.01.

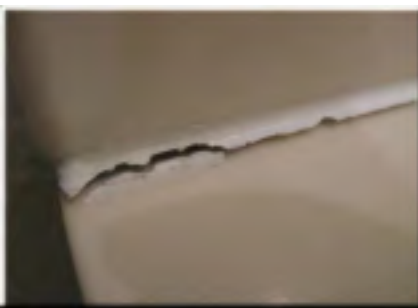
Photo: 6710 (1)

[R] 6710: Caulk at left side of sink perimeter in lower level bathroom is cracked/gapped, increasing risk of moisture intrusion, which may cause deterioration or microbial growth. Inspection beyond the surface is beyond the scope of a home inspection. Recommend that this finding, all associated components, and remaining bathroom caulking be reviewed, and corrected as needed, by an appropriate, qualified contractor. See Photo(s) 6710.

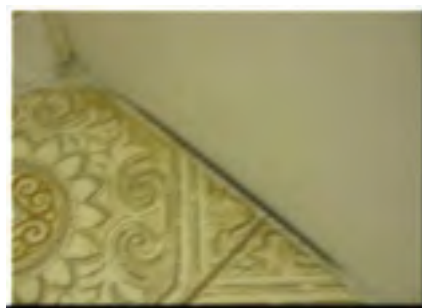
Photo: 6770.03 (1)

[R] 6770.03: Caulk between floor and tub and at bottom of shower wall in upper level bathroom is deteriorated/missing/cracked, possibly allowing moisture intrusion, which can deteriorate inner

building materials and promote microbial growth. Determining whether these conditions exist under the caulk is beyond the scope of a home inspection and would require intrusive inspection by an appropriate specialist. Recommend that this finding, all associated components, and remaining caulking in bathroom(s) be reviewed, and corrected as needed, by a qualified contractor. See Photo(s) 6770.03.

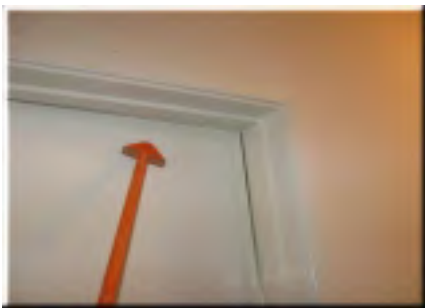
Photo: 7300.01 (1)

[R] 7300.01: Door to left bedroom drags door jamb. Various possible causes, such as excessive paint, misalignment, or building movement. Recommend that this finding and all associated components be reviewed, and corrected as needed, by an appropriate, qualified contractor. See Photo(s) 7300.01.

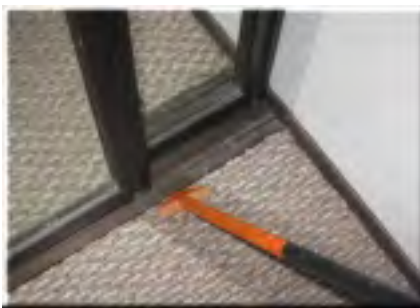
Photo: 7370.10 (1)

[R] 7370.10: Sliding door for right bedroom closet appears to contact screw in lower track, preventing door from moving all the way to the right. Recommend correction by a qualified person. See Photo(s) 7370.10.

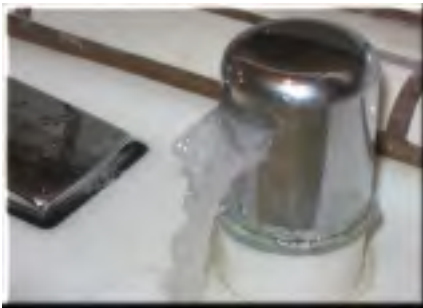
Photo: 8310 (1)

[R] 8310: Dishwasher drainage is discharging through "air gap" on kitchen sink, indicating possible drain clog/restriction in drain pipe between air gap and disposal. May indicate disposal outlet tab not removed. The purpose of the air gap is to provide an alternate path for drain contents to backup into sink instead of backing up into dishwasher and onto dishes when drain is clogged. Recommend that this finding be reviewed, and corrected as needed, by a qualified licensed plumbing contractor. See Photo(s) 8310.
